PLASTICS AND ELECTRONICS

Failure of plug and circuit board after storage in damp conditions

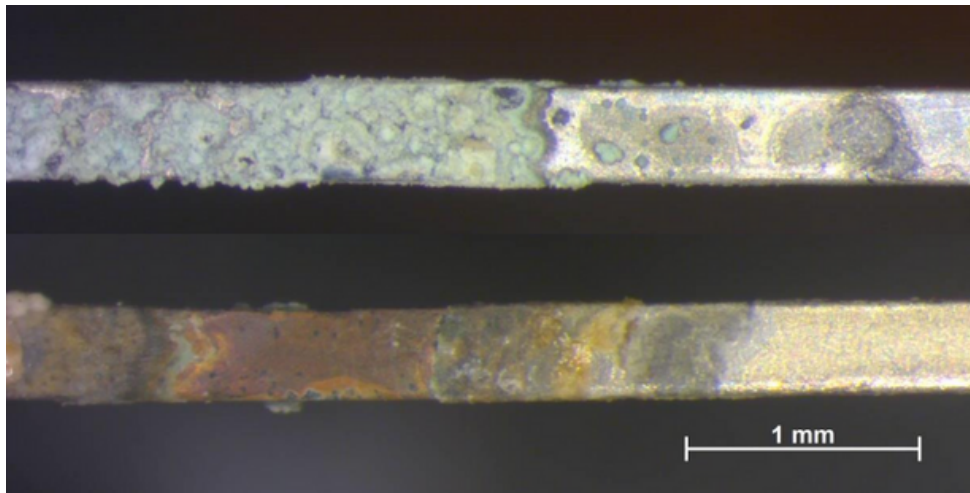
A light microscopic examination at Analytik Service Obernburg showed clear discoloration of connector pins (Fig. 1), solder contacts and circuit board (Fig. 2).

Fig. 1: Discoloration of the connector pins after disassembly.

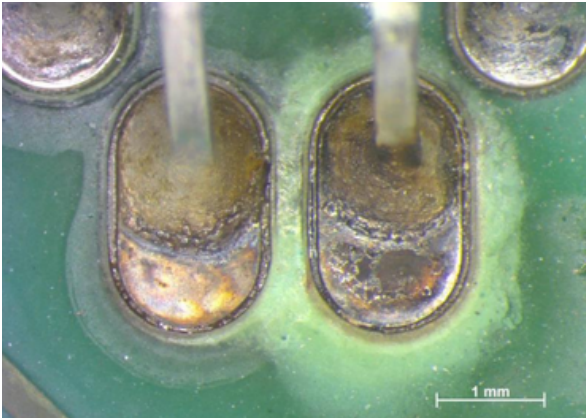
Fig. 2: Discoloration of solder contacts and circuit board

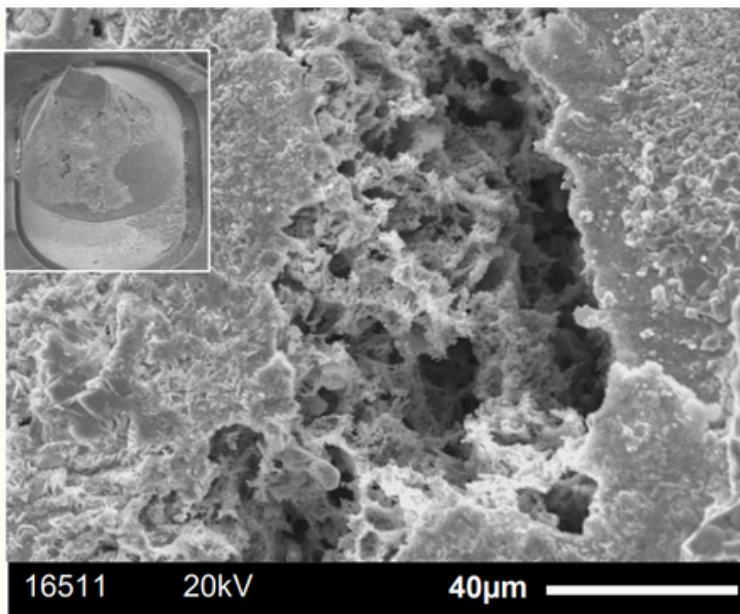
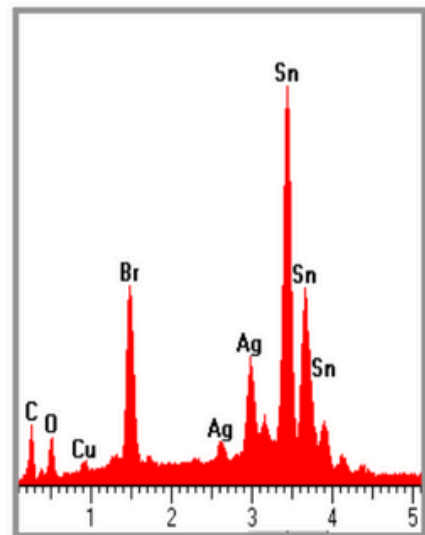
While clear corrosion involving bromine could be detected on the positively charged pin (Fig. 3), the discoloration of the circuit board next to the grounded pin contains significant amounts of potassium (Fig. 4). Based on the measurement results, it was assumed that alkali halides were added to the plastic of the connector to achieve heat resistance, which were dissolved out of the polymer by temperature and humidity. The applied voltage caused the ions to migrate, which in turn caused the chemical changes. An examination of the plastic and simulations confirmed the assumption.

Fig. 3: Chemical attack of the solder with indications of bromine at the positive pole

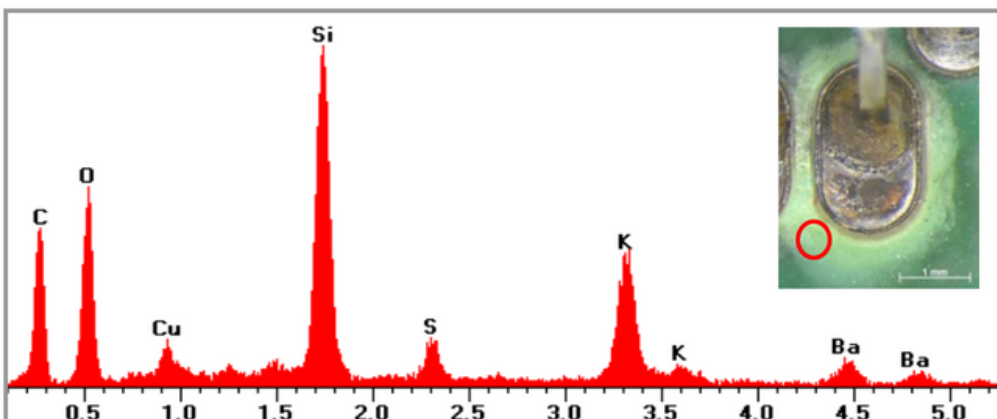
Fig. 4 Accumulation of potassium in the protective coating around the earthed pin
