BLISTERING ON GALVANIZED COMPONENT

Determine causes of defects after climate simulation

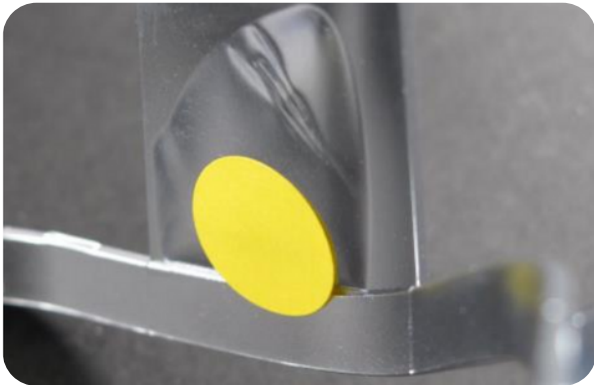
Several apparently perfectly galvanized PC/ABS components showed clear blistering in some areas after a temperature cycling test (Fig. 1). This led to the entire production batch being blocked.

Fig. 1: Galvanized component with blistering

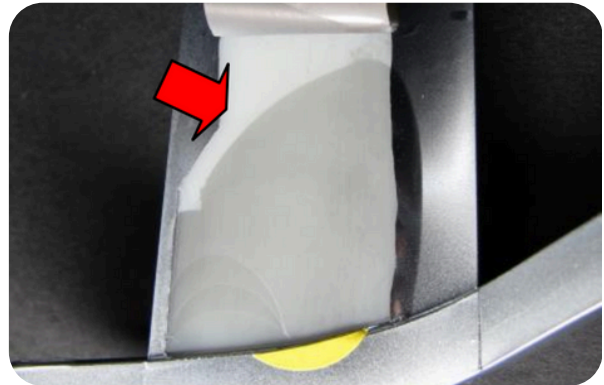
The bubble was opened at Analytik Service Obernburg. The polymer surface below the bubble appears darker than in the freshly removed reference area (red arrow in Fig. 2). In the bubble area, hardly any polymer adheres to the metal, while the adhesion in the reference area is so high that part of the polymer was torn off when the metal layer was peeled off - the underside of the metal is covered by numerous polymer flags (Fig. 3). In a further step, the polymer in the reference area was chemically dissolved away and the metal underside exposed (Figs. 4 and 5), revealing a cavern structure of varying degrees of intensity.

Fig. 2: Opened bladder

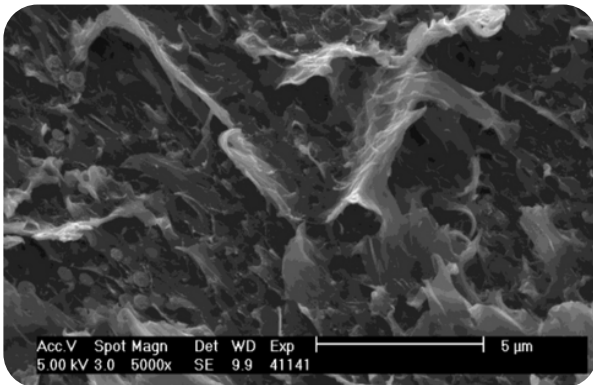
Fig. 3: Metal underside of the reference area with adhering polymer

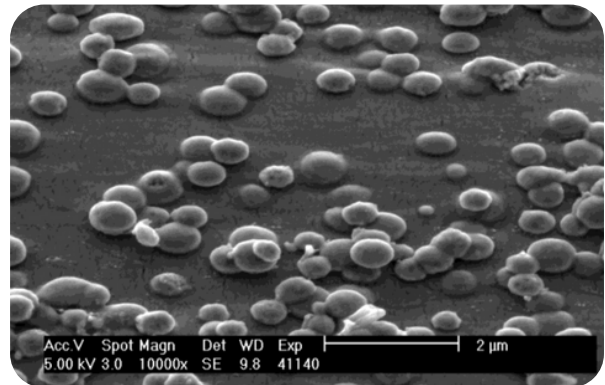
Fig. 4: Metal underside in the bubble area with relatively few anchoring points

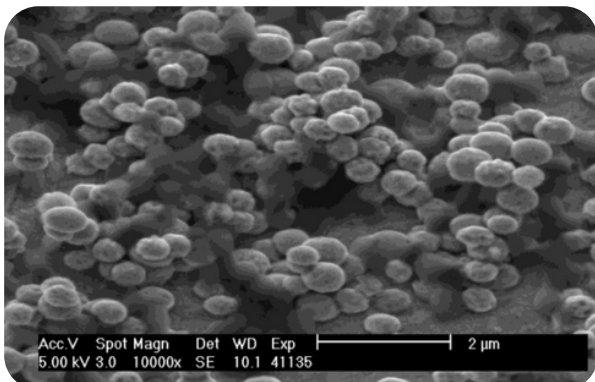
Fig. 5: Cleaned metal underside in the reference area (many spherical caps allow an intimate connection with the polymer)

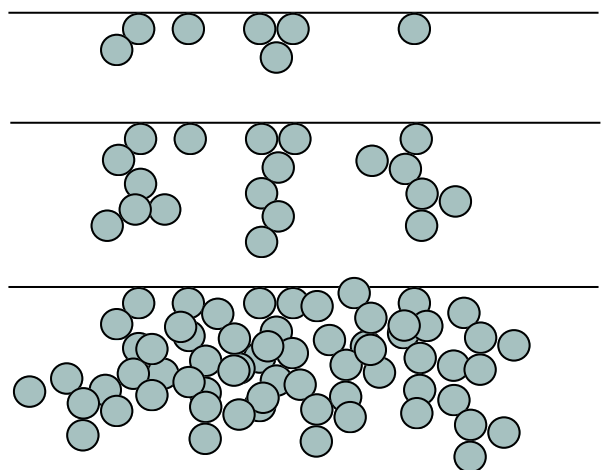
Fig. 6a-c: Surfaces stained to different degrees

During electroplating, the butadiene component of the ABS is first oxidized in a pickling process. This creates a cavern structure that is filled with metal in the subsequent process steps, which causes the anchoring. If the pickling is too low (Fig. 6a), too few anchoring points are created. If, on the other hand, it is too high (Fig. 6c), too few polymer bars remain and the strength is also reduced.
