## BUBBLES ON PAINTED INJECTION-MOLDED PART

### TASK

After painting an injection molded component, defects in the form of tiny, punctiform elevations were detected, which render the component unusable (Fig. 1). In order to reduce the reject rate, it is necessary to know the cause of the defects and the associated process step.

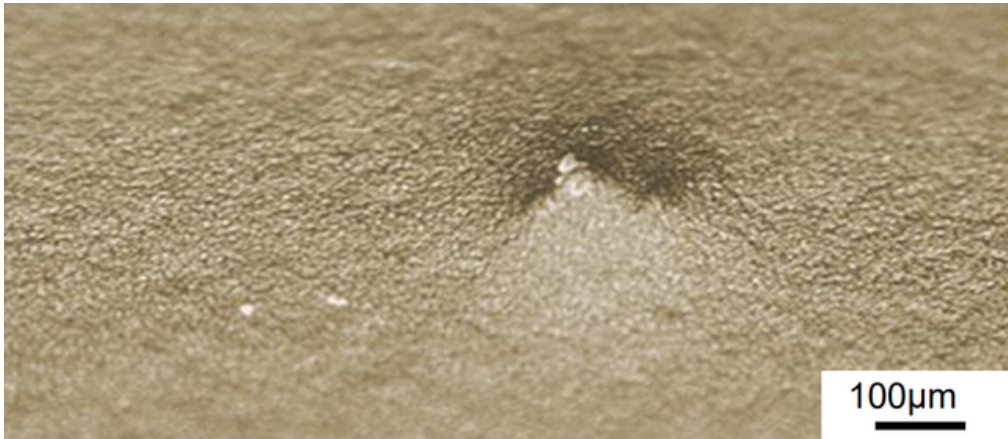
Fig. 1: Bubbles in varnish layer

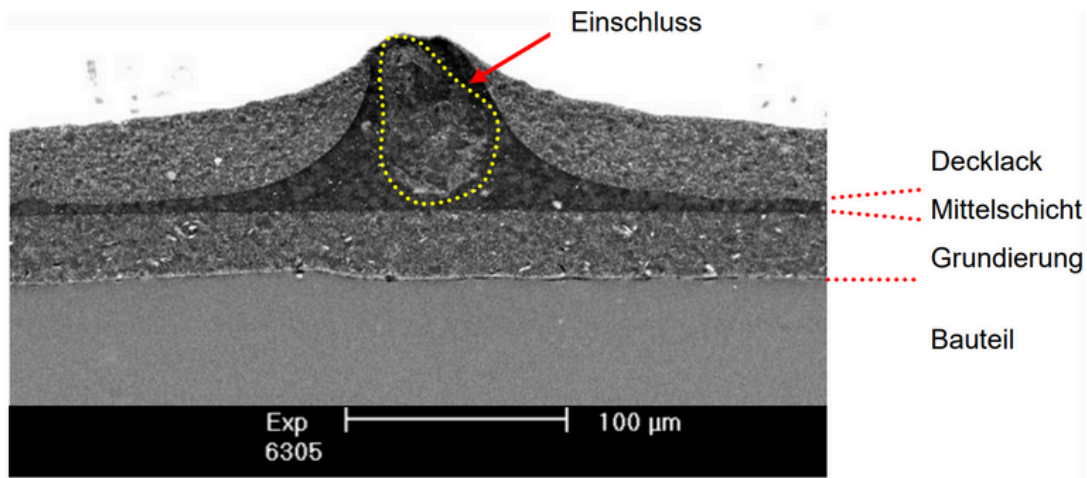
In such cases, Analytical Services Obernburg uses analytical scanning electron microscopy (SEM-EDX). The cross-section shows the structure of the coating (primer, middle layer and top coat). The defect is clearly located within the middle layer and is surrounded by it on all sides (Fig. 2). Contamination of the surface of the injection molded part before painting can therefore be clearly ruled out.

Fig. 2: Cross-section through defect in varnish layer (material contrast)

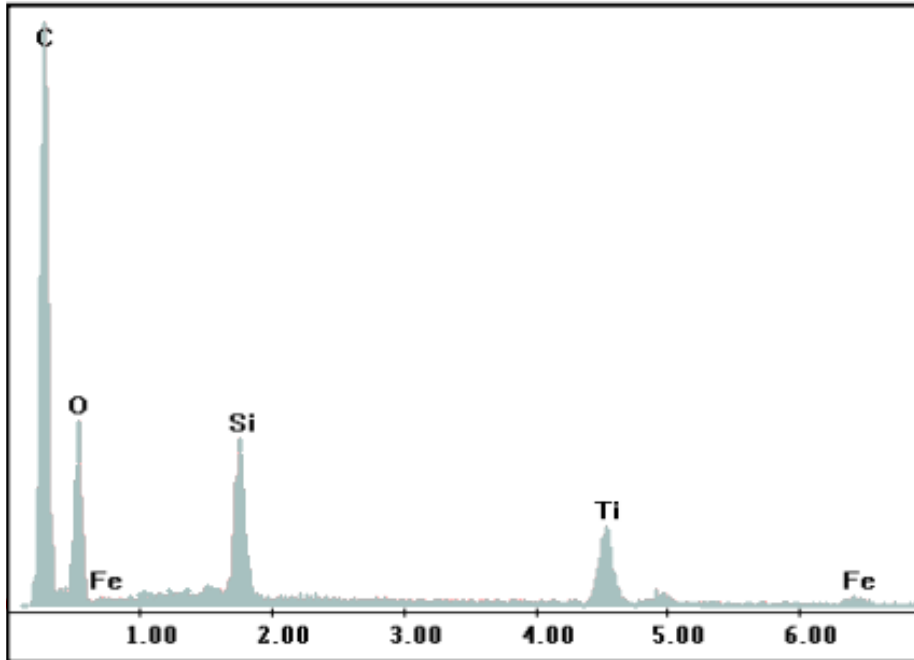
The element composition of the inclusion (Fig. 3) corresponds to the composition of the top coat. It is an organic varnish colored with a ferrous dye, silicate as a filler and titanium dioxide as a matting agent. The size and distribution of the fillers is also comparable in both areas (Fig. 4). Consequently, the coating of the component was not done properly. A paint particle of the top coat either got onto the finished primer and was infiltrated by the paint of the middle layer or it was applied together with the paint of the middle layer during the painting process.

Fig. 3: Determination of the local element composition within the defect using energy-dispersive X-ray spectroscopy (EDX).

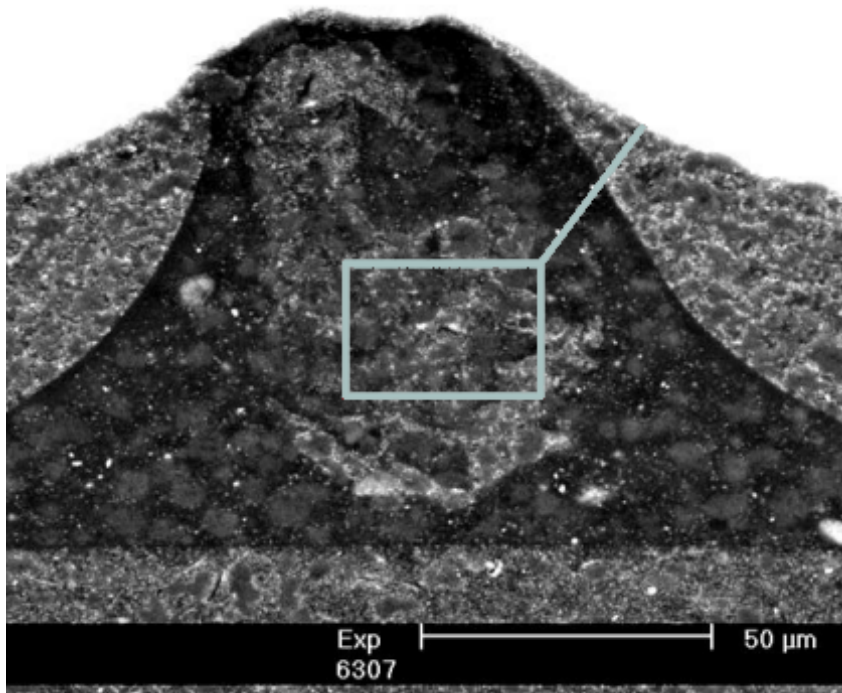
Fig. 2: Cross-section through defect in varnish layer (material contrast)
