LACQUER ADHESION

EXAMPLE - PAINT DEFECT (WETTING PROBLEM)

EXAMPLE - REDUCED PAINT ADHESION

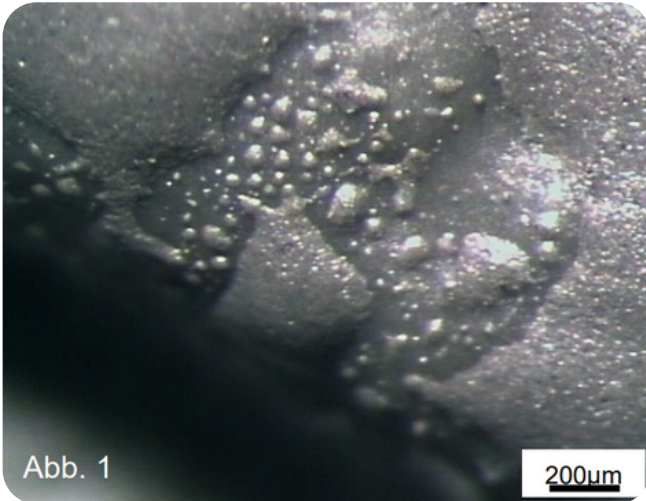
Poor wetting of a plastic component is indicated by the formation of droplets in the paint (Fig. 1). The ESCA overview spectrum in Fig. 2 shows a high silicon concentration (8-14 at%) in the defect area (red spectrum). Based on the Si2p binding spectrum (Fig. 3), the silicon can be clearly assigned to a silicone oil. After cleaning the surface with acetone, the silicone oil disappeared (green spectrum in Fig. 2). Silicone contamination as the cause of the defect is thus clearly proven.
